# Timbrell Park Sportsfield Minor Works

## Due Diligence Aboriginal Archaeological Assessment

Report to  
**City of Canada Bay**

June 2025

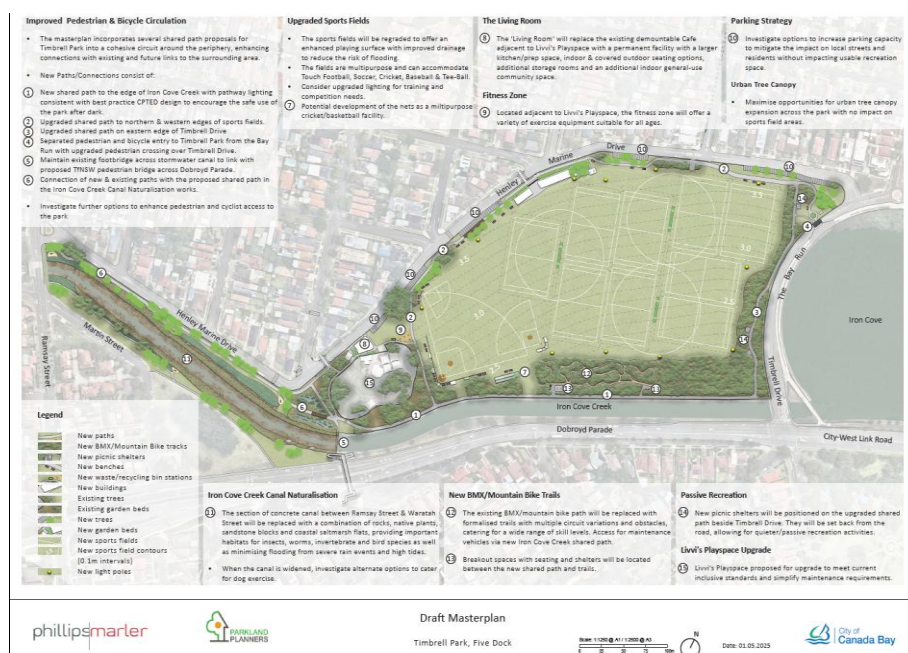
Figure 1.2: Timbrell Park Draft Masterplan (City of Canada Bay 2025)

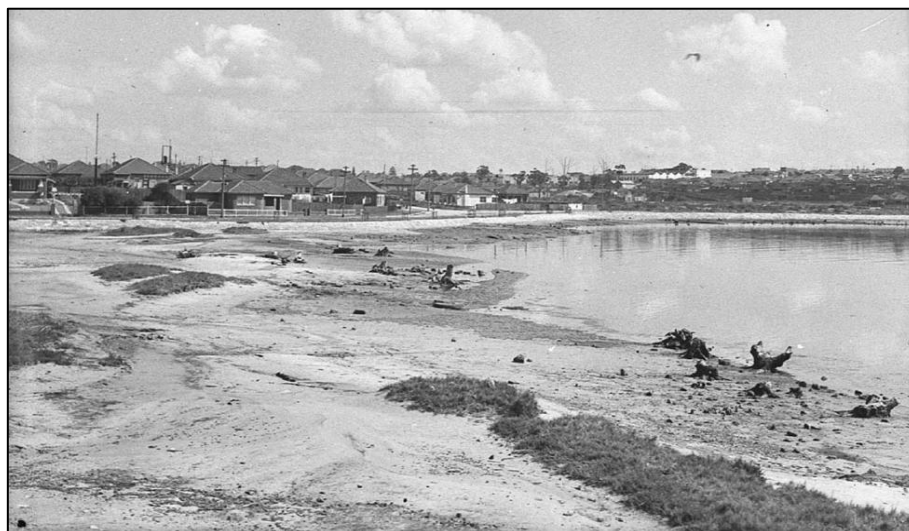
Figure 2.3: Reclamation works at Timbrell Park 1941 (Source: State Library of NSW 2019)

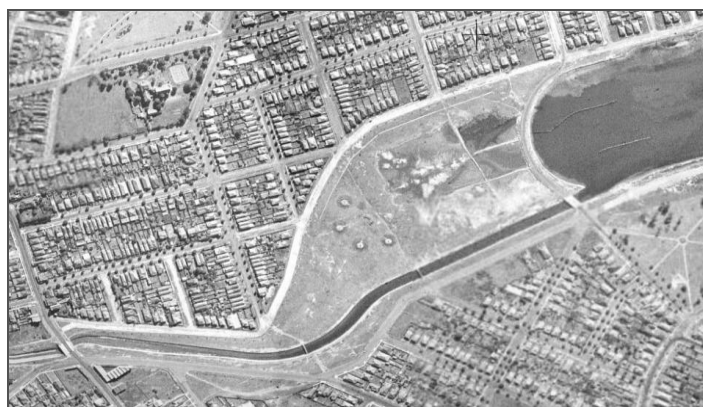
Figure 2.4: The final stages of reclamation of Iron Cove and creation of Timbrell Park – draining and filling behind the sandstone seawall at the head of the bay – in 1942 (Six Maps 2019)

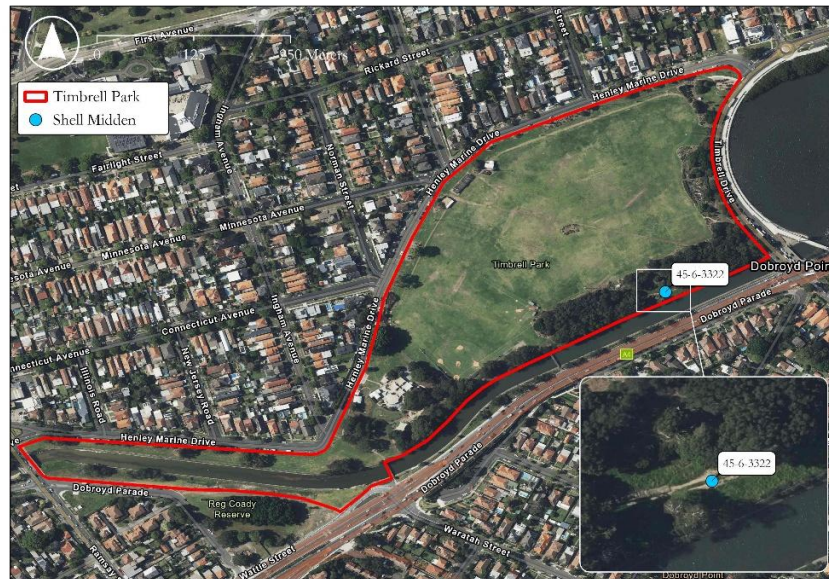
Figure 3.1: AHIMS map for Timbrell Park

Searches of AHIMS (Client Service ID: 1013540, 16 June 2025) show one AHIMS recording within Timbrell Park (AHIMS ID 45-6-3322). The site card is appended and described below.

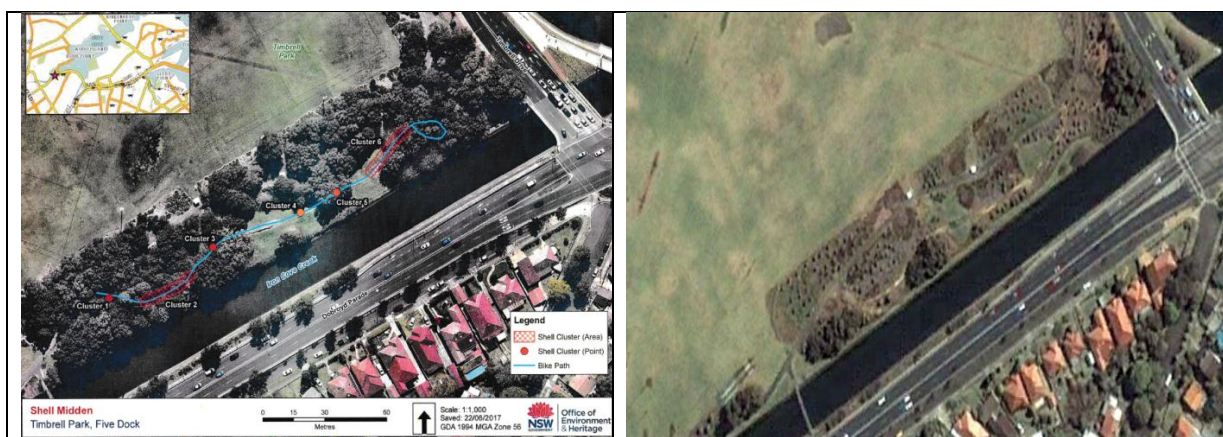
Figure 3.1: Image to the left shows shell materials recorded as AHIMS #45-6-3322 (majority Sydney cockle – no bones or stone artefacts apparent) exposed around earthworks (ramps and bridges) associated with a bike track located within this planted and landscaped zone. The image to the right shows the newly created landscape zone in 2000. The shell materials may have been disturbed in situ by the construction of the bike track or brought in as fill

This site recording is for shell materials that are in the southeast of the parkland. These shells are believed to be natural rather than cultural in origin and to derive from reclamation fills that occur below current surfaces that appear to have been exposed and upcast by excavations in recent times. The appended site card describes the site comprising several dense clusters of shell exposed from past earthworks for ramps and approaches associated with bike tracks within the planted and landscaped area illustrated below.

The results of stratigraphic recording and chemical analysis at AHIMS #45-6-3322 demonstrated the shell deposits are not cultural in origin but are natural shells that form part of modern and contaminated reclamation fill materials that have been upcast from below ground by excavations undertaken for the creation of a bike track in the southeast corner of the park.
