## Lighting Impact Assessment

Our ref: 560 Timbrell-2 Issue A

15-17 Regatta Road Fivedock NSW 2046

## Timbrell Park

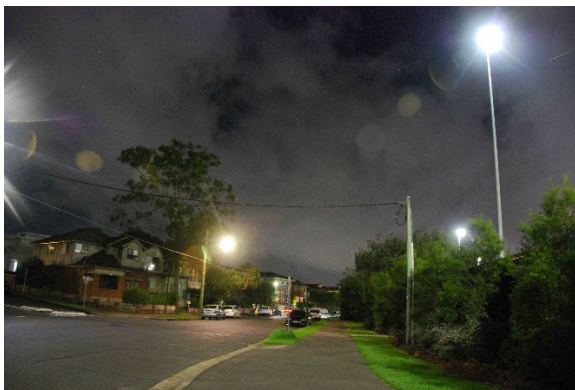
Existing floodlighting viewed from Henley Marine Drive:

The photos below illustrate the combined effect of the field lighting and street lighting along Henley Marine Drive. By itself the street lighting has reasonable impact on the property building boundaries. The field lighting adds to the obtrusive lighting.

When measuring the obtrusive impact of the field lighting the street lighting was shielded from the light meter sensor. The results are considered close but indicative only as reflectance's from road, building and vegetation cannot be eliminated.
